FINAL REPORT *OF* A BOARD OF INVESTIGATION

*To Inquire Into*  
THE DESIGN  
AND METHODS OF CONSTRUCTION  
OF WELDED STEEL MERCHANT  
VESSELS

15 JULY 1946

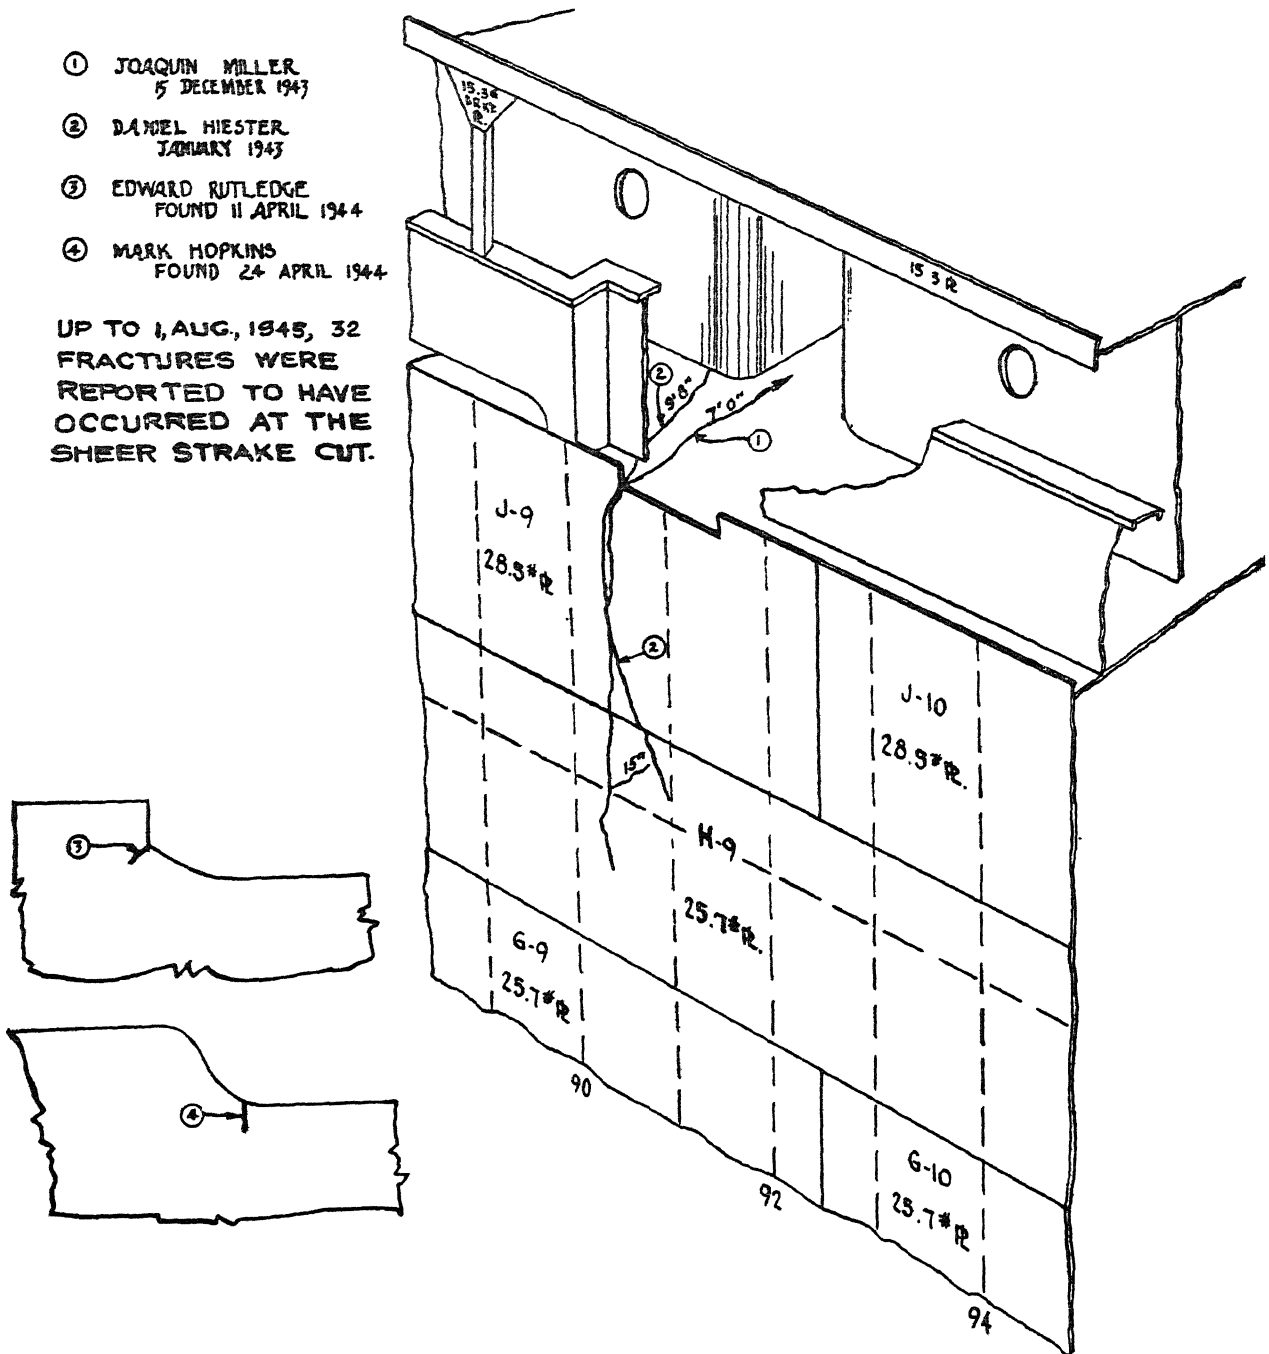
Figure 35.

UP TO 1, AUG., 1945, 32  
FRACTURES WERE  
REPORTED TO HAVE  
OCCURRED AT THE  
SHEER STRAKE CUT.

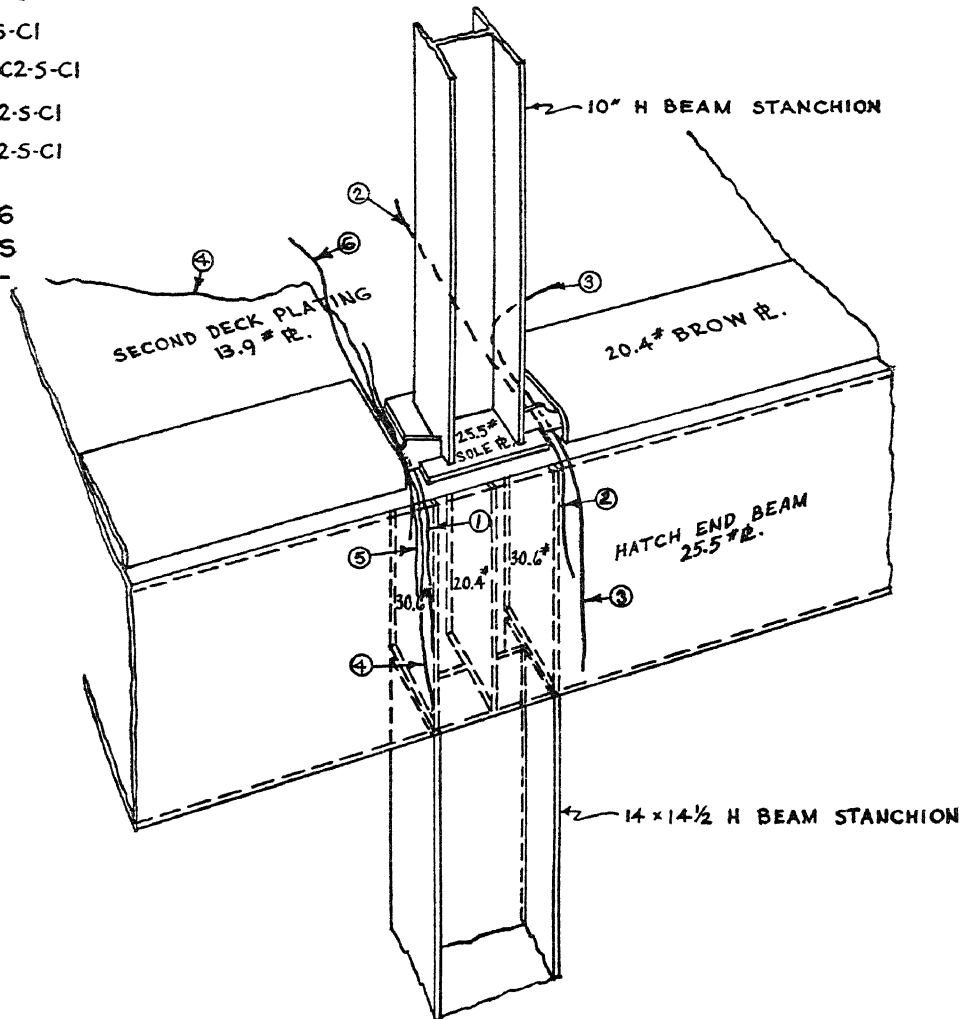
Figure 36.

UP TO 1, AUG, 1945, 36  
FRACTURES OF THIS  
TYPE HAD BEEN RE-  
PORTED, INCLUDING  
19 IN No. 2 HATCH

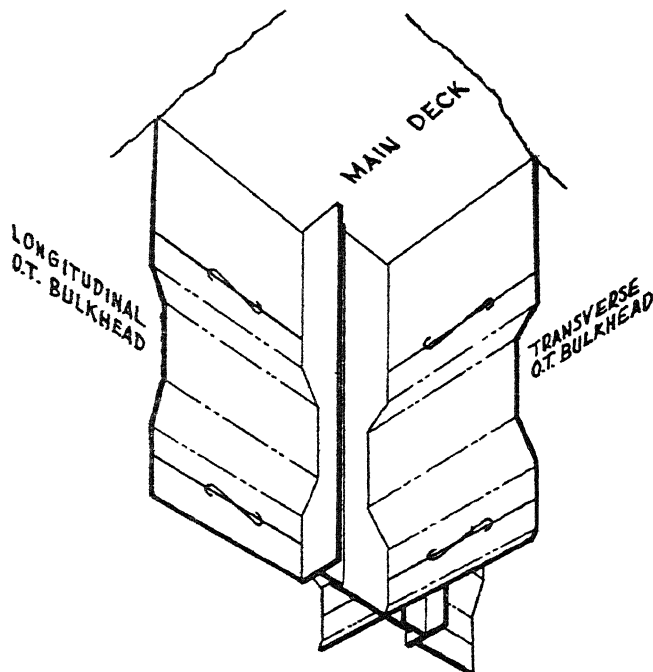
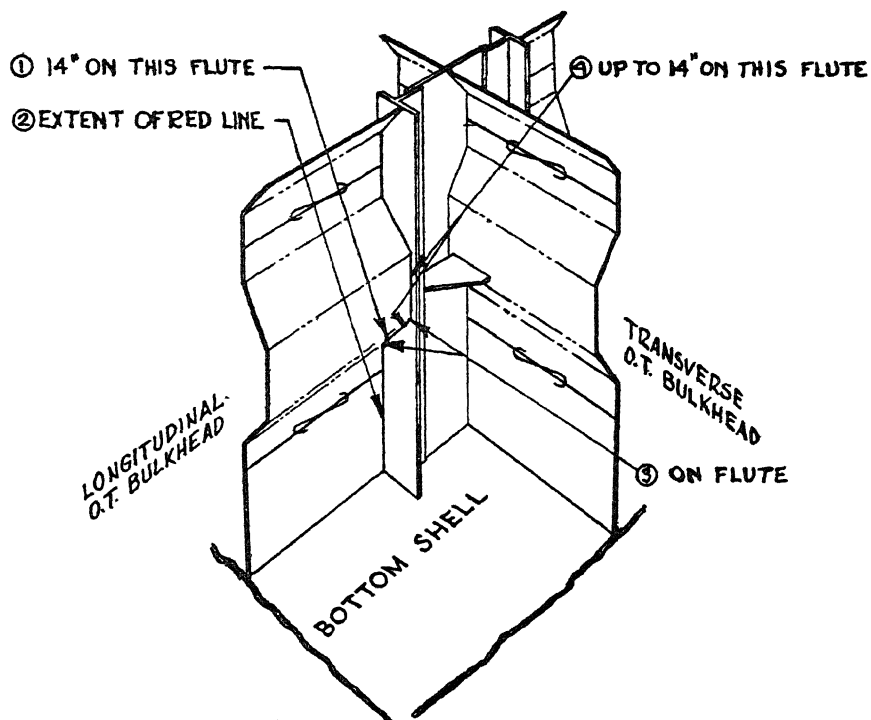
Figure 39.

**T2-SE-A1 TYPE**  
**COMPOSITE SKETCH OF FRACTURES**  
**CONNECTION OF FLUTED LONGITUDINAL BULKHEADS TO TRANSVERSE BULKHEADS**

UP TO 1 AUG. 1945 325 FRACTURES  
 WERE REPORTED AT THESE  
 BULKHEAD INTERSECTIONS.

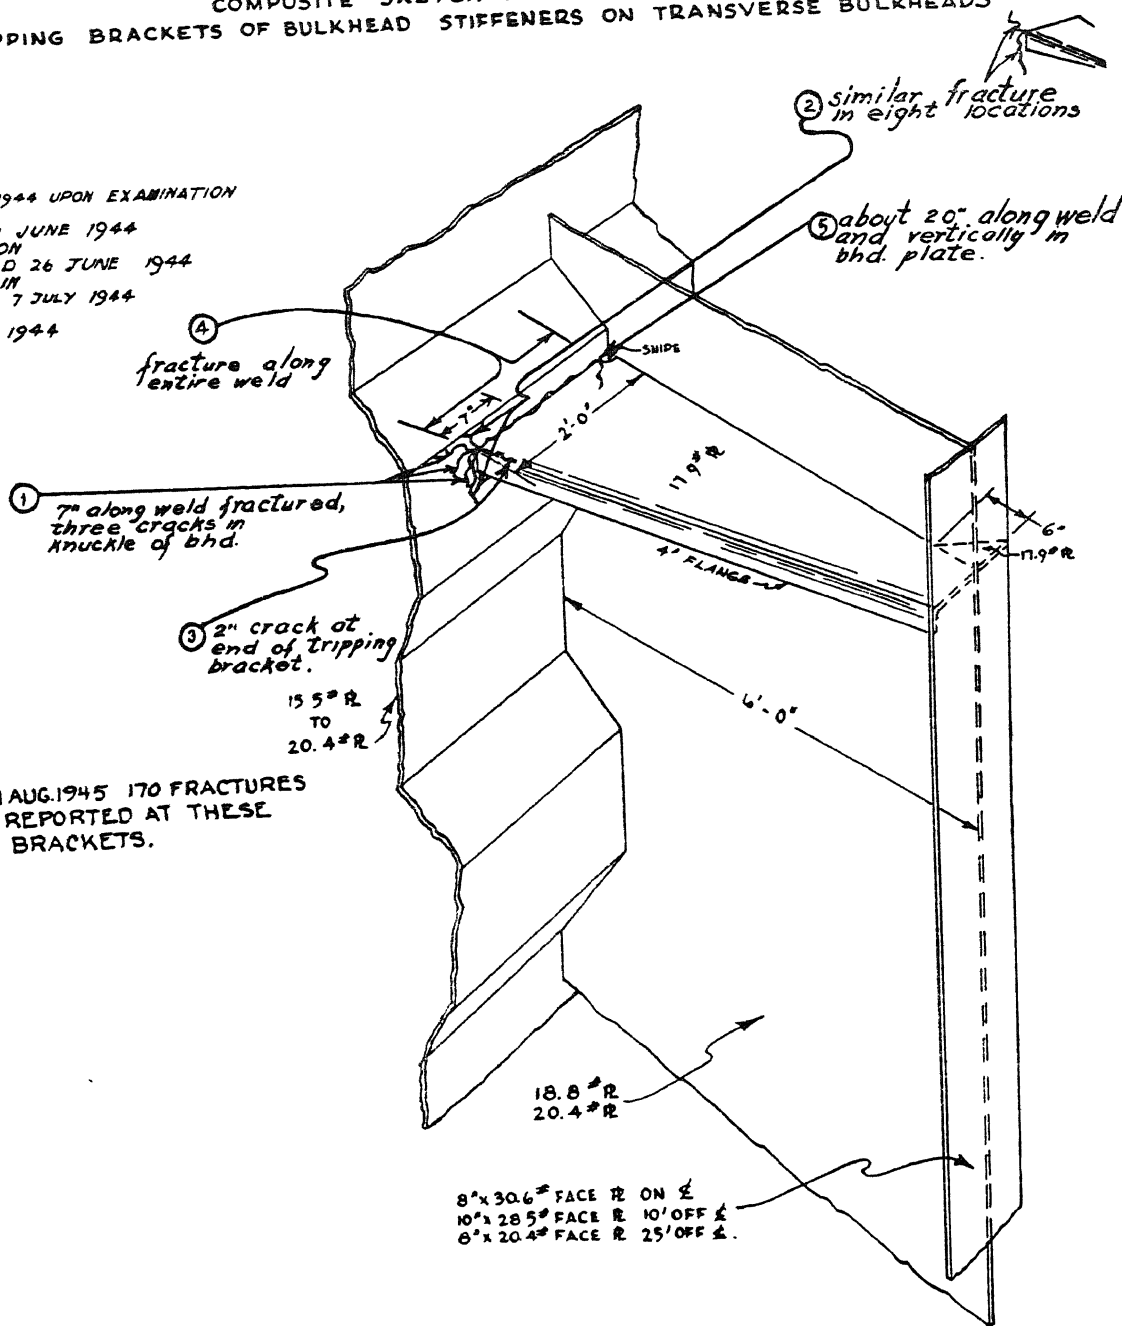
UP TO 1 AUG. 1945 170 FRACTURES  
 WERE REPORTED AT THESE  
 BRACKETS.

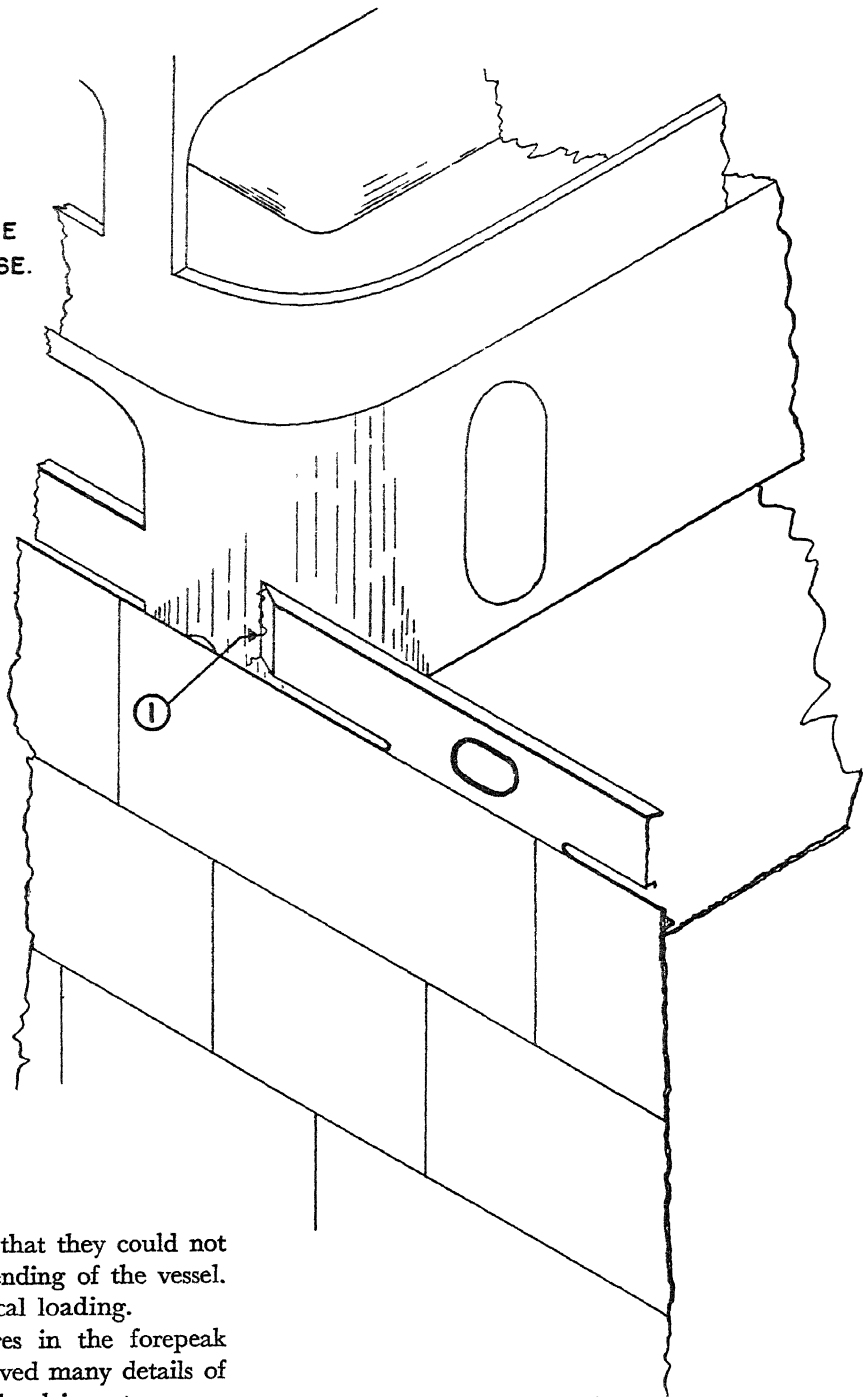
Figure 41.

VICTORY SHIP  
TYPICAL BULWARK FRACTURE  
AT FWD. END OF DECK HOUSE.

tion of these fractures indicated that they could not be related to the longitudinal bending of the vessel. They apparently result from local loading.

Most of the bulwark failures occur at the forward and aft end of the deck house where the bulwark is flanged to land perpendicular to the rounded house front, figure 41. This is a poor design detail but is not a dangerous feature because experience with the Liberties led to constructing the Victory bulwarks free of the top of the sheer strake. This freedom prevents the cracks from propagating into the hull.

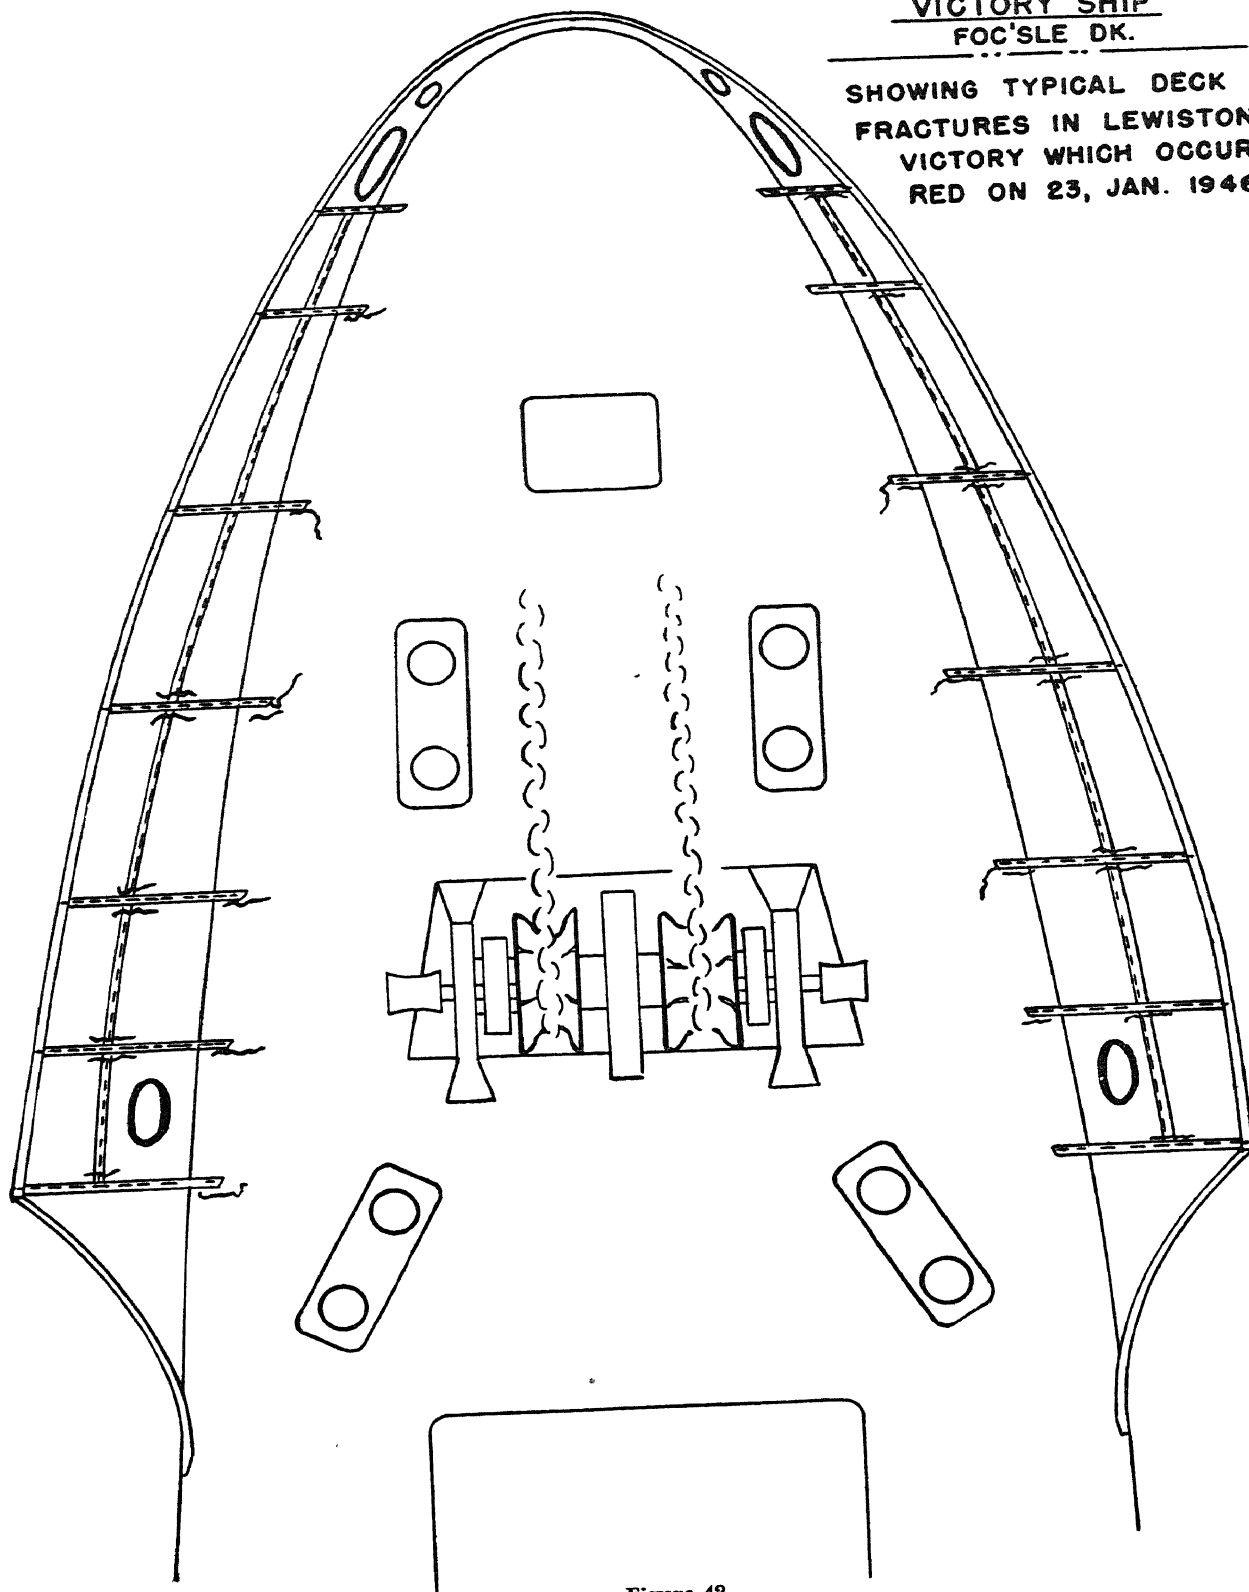
Figure 42.

SHOWING TYPICAL DECK  
FRACTURES IN LEWISTON  
VICTORY WHICH OCCUR-  
RED ON 23, JAN. 1946

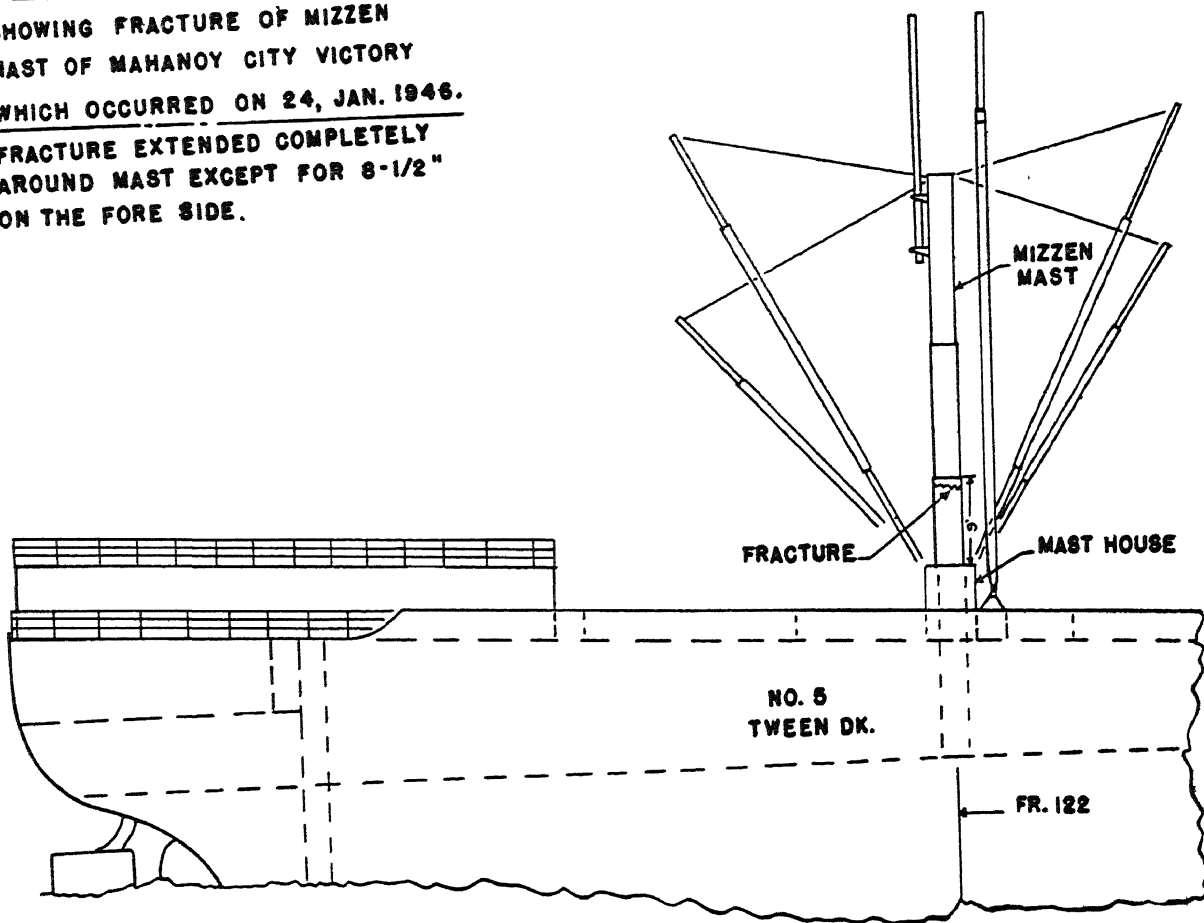
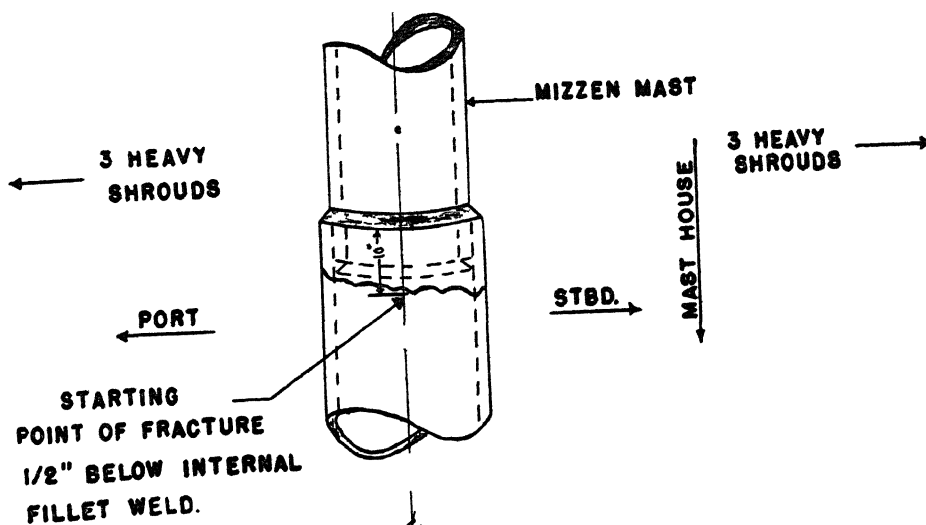
Figure 43.

FRACTURE EXTENDED COMPLETELY  
AROUND MAST EXCEPT FOR 8-1/2"  
ON THE FORE SIDE.

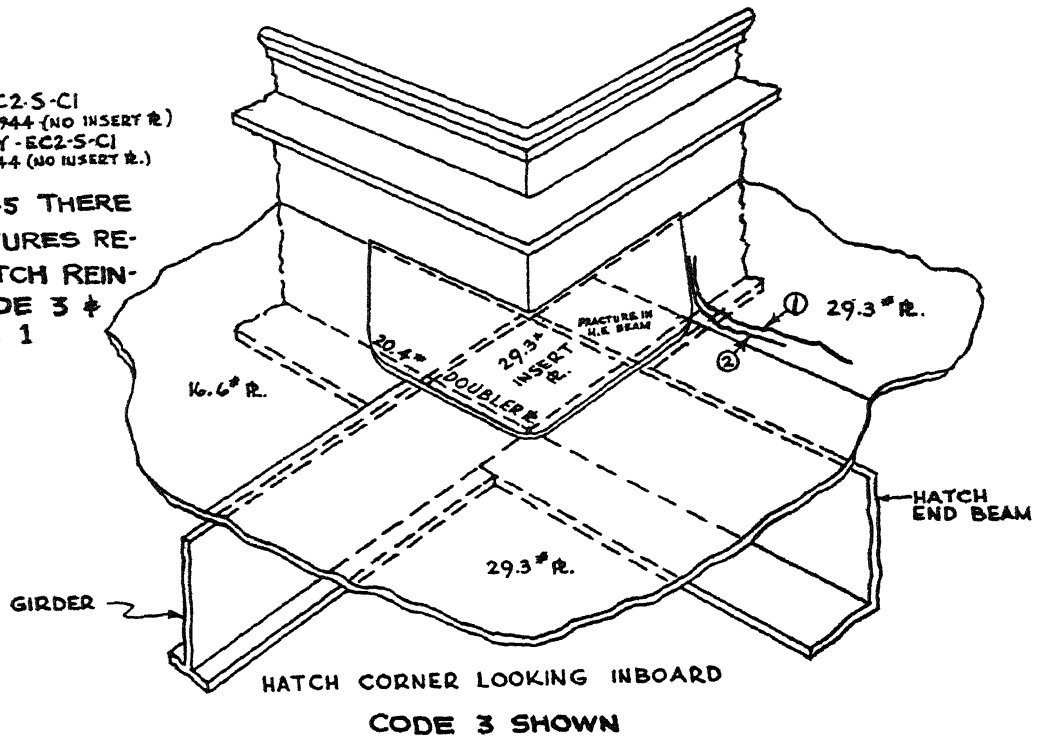
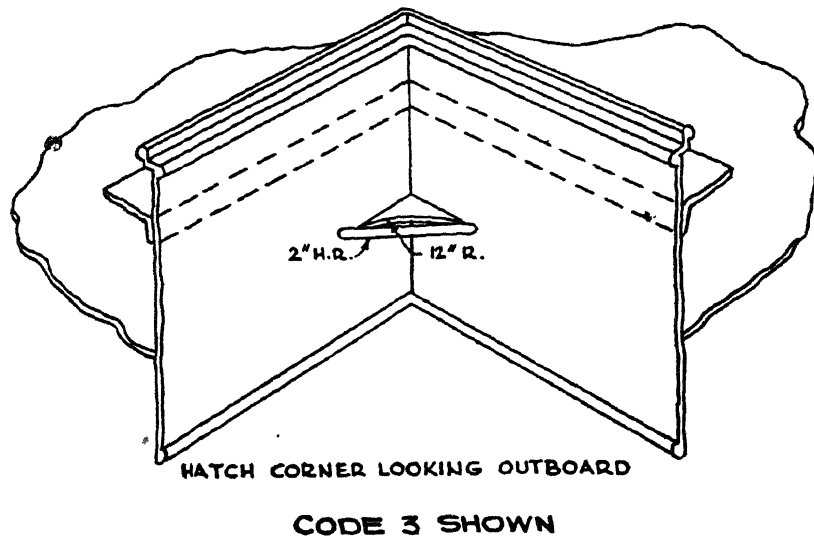
Figure 47.

UP TO 1, AUG. 1945 THERE  
WERE 5 FRACTURES RE-  
PORTED ON HATCH REIN-  
FORCEMENT, CODE 3 &  
NONE ON CODE 1

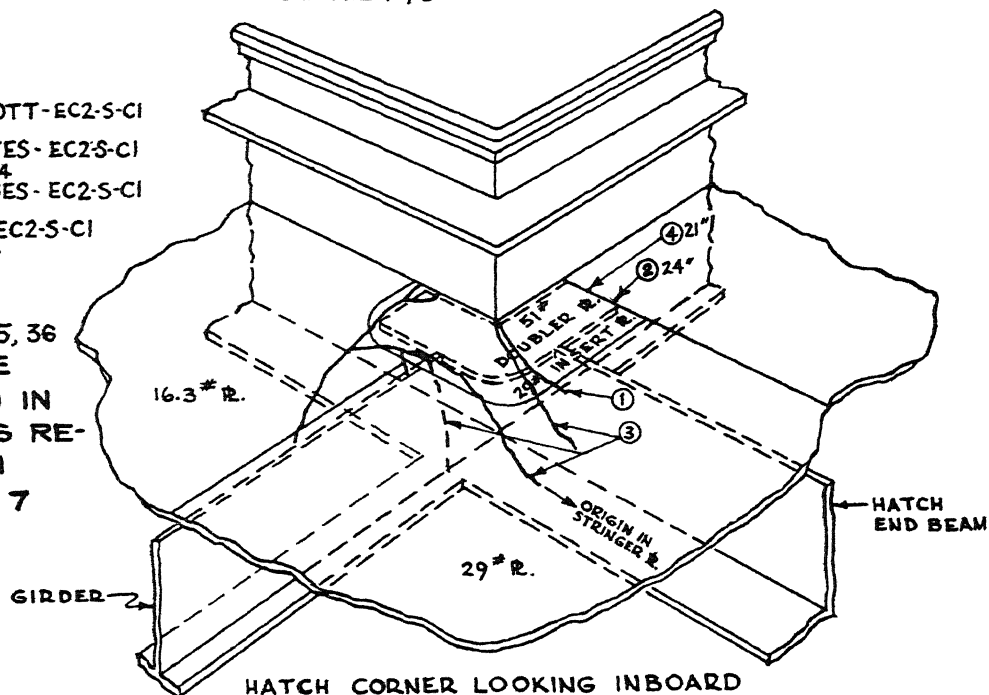
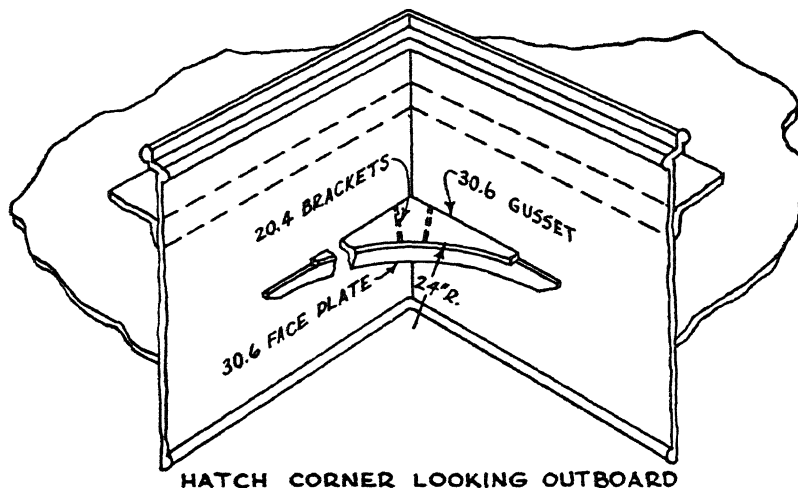
Figure 48.

UP TO 1, AUG, 1945, 36  
 FRACTURES HAVE  
 BEEN REPORTED IN  
 HATCH CORNERS RE-  
 INFORCED WITH  
 CODES 5, 6, & 7

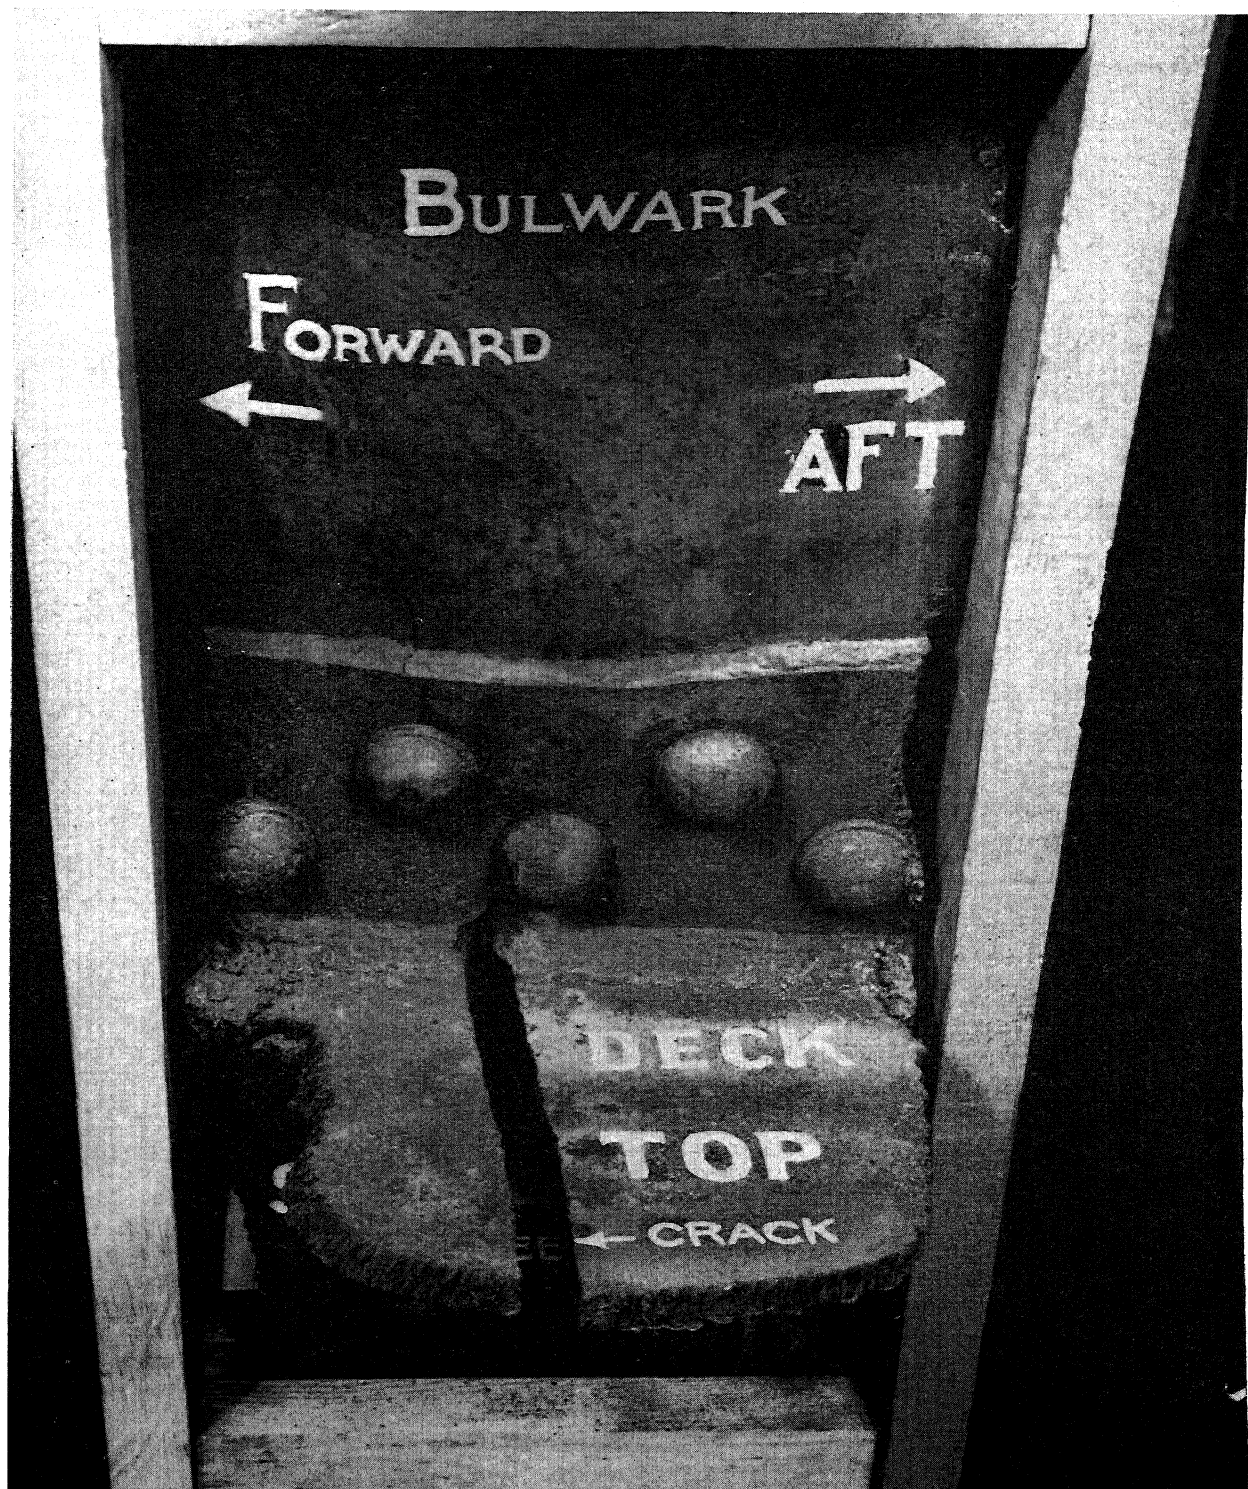
Figures 53, 54 and 55 describe a typical case of an effective crack arrestor. The photographs were taken

FIGURE 54.—Termination of fracture at gunwale, starboard side, *S. S. Colin P. Kelly Jr.* (see arrow fig. 53.)

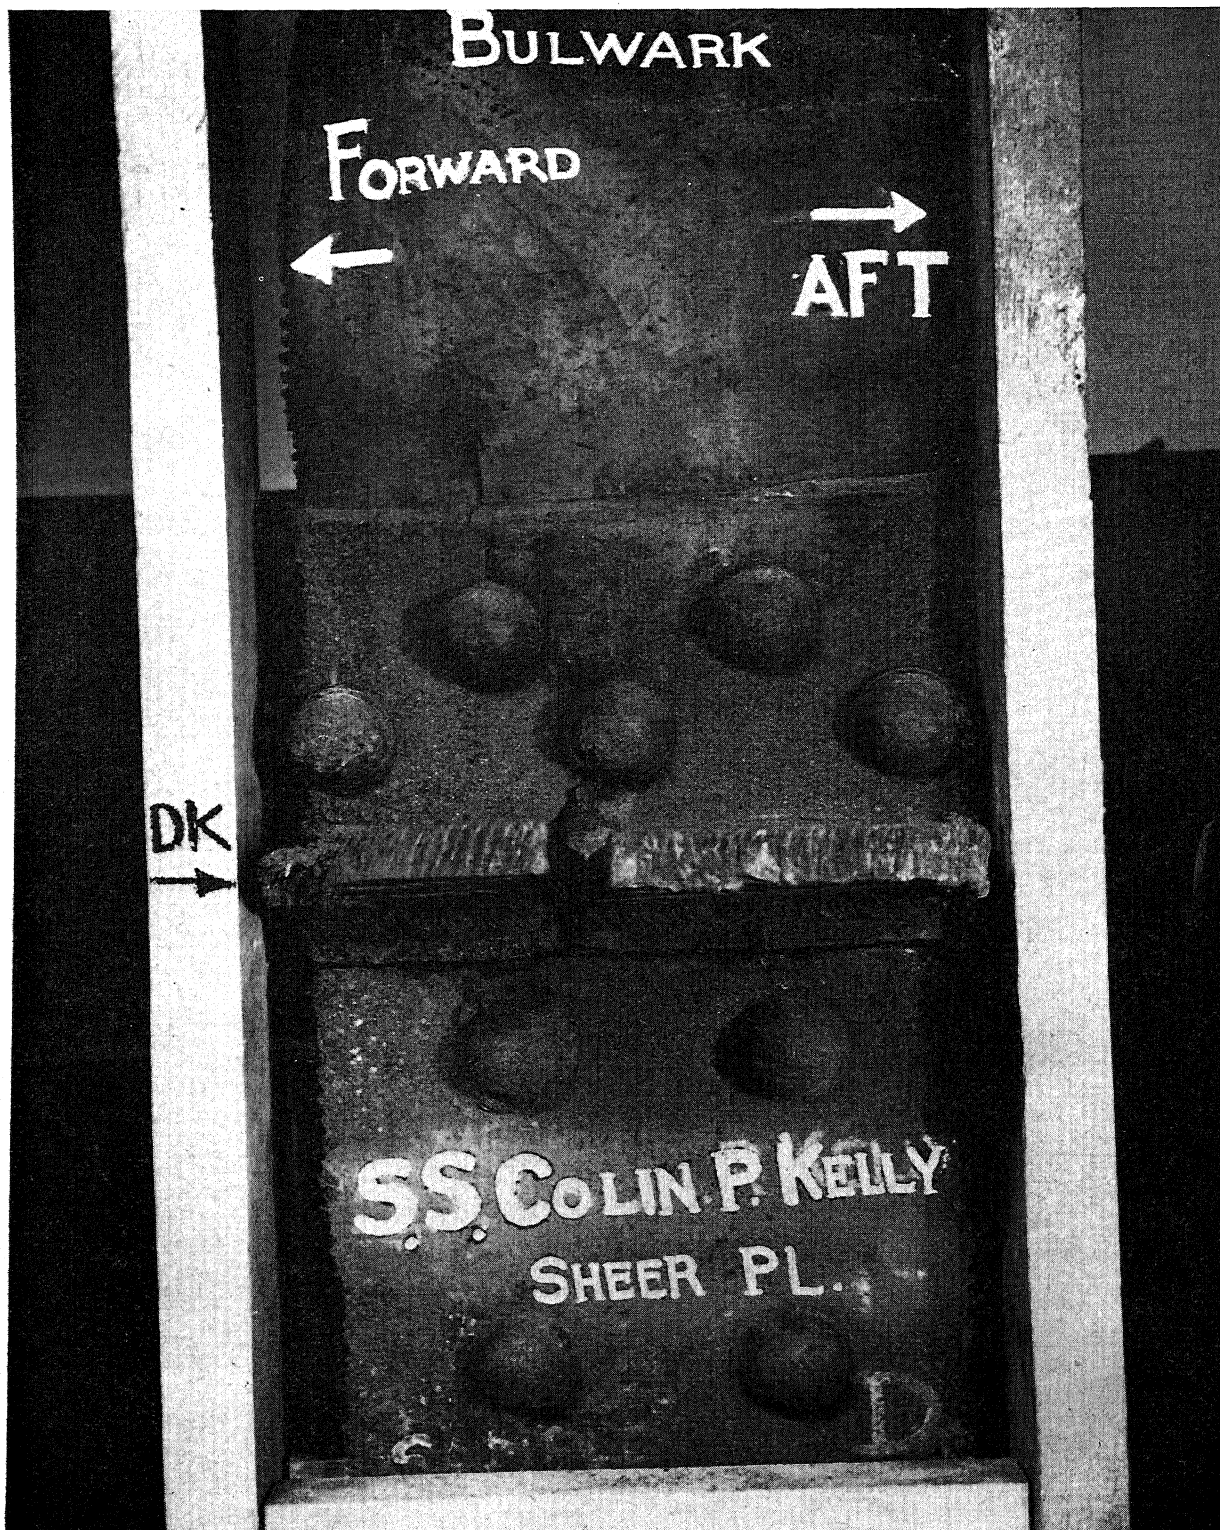
FIGURE 55.—Termination of fracture at gunwale, starboard side, *S. S. Colin P. Kelly Jr.* (Note horizontal torch cut below deck, see fig. 52.)

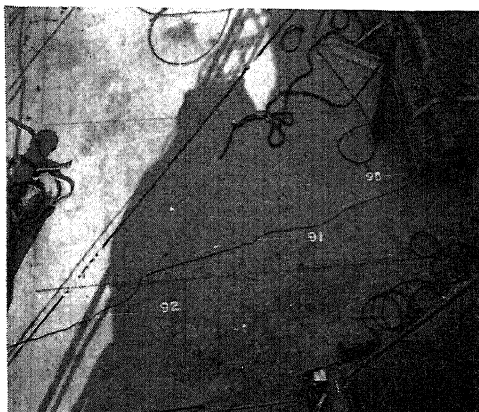
FIGURE 1

WEATHER DECK OF S.S. SEA BASS AS VIEWED FROM ABOVE SHOWING FRACTURE FROM THE AFTER PORT CORNER OF NO. 3 HATCH.

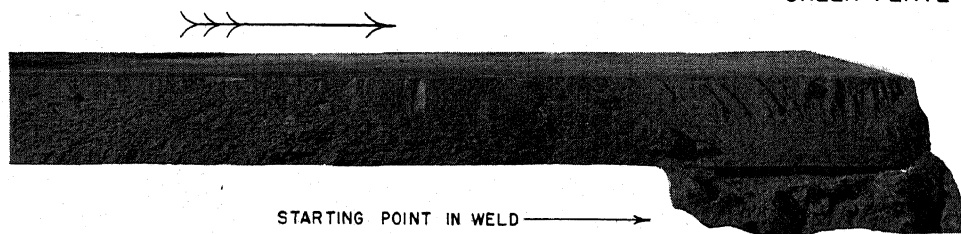
FIGURE 3

FRACTURED 51\* DECK PLATE FROM FIGURE 2 SHOWING POORLY FUSED WELD IN UPPER FLANGE OF LONGITUDINAL HATCH SIDE GIRDER.
